**A HUMAN FACTORS APPROACH
TO USE OF GPS RECEIVERS**

Ruth M. Heron

Heron Ergonomics Inc.

Aircraft Certification Directorate

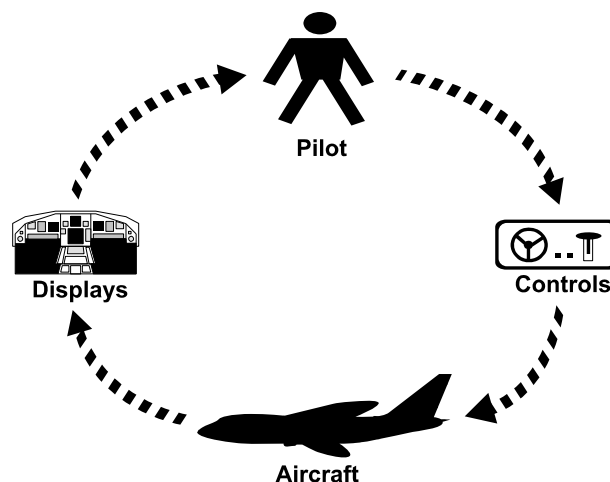
Figure 1. Information exchange in the closed loop pilot/aircraft system.

and the behaviour of the aircraft), as well as from its environment; the resulting changes in the aircraft's behaviour are fed back to the pilot, and the cycle begins again. Input to the pilot, of course, goes far beyond feedback from the aircraft and its environment. Information is also received from many external sources, and *all* relevant input must then be processed in the brain in a way that enables the pilot to operate the aircraft in a safe and efficient manner. Clearly, a requisite for this outcome is that feedback from the machine be swift and accurate.

Although consideration of information from external sources adds a measure of complexity to the model shown in Figure 1, this model is still far too simplistic to cover a system that includes a GPS receiver. The receiver can be thought of as a subsystem that adds another closed loop, complete with controls and displays, that interacts with the basic one, as shown in Figure 2. The process involves activation of control keys by the pilot, this resulting in a change in

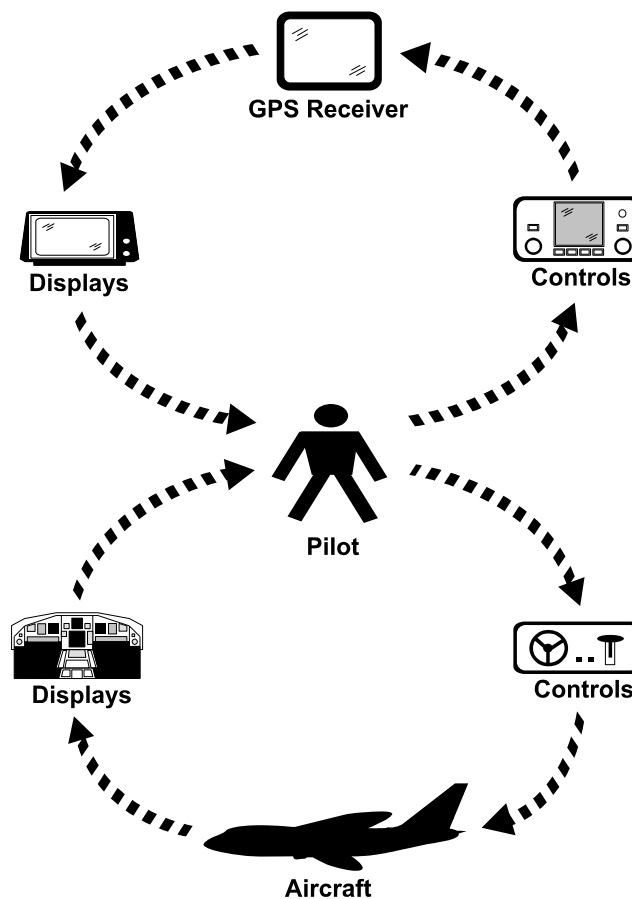
Figure 2. Operation of the GPS adds another closed loop to the pilot/aircraft system.

the status of the receiver system, which is fed back to the pilot on the system's displays. The pilot then uses this information, along with information obtained through the major loop, to control the aircraft. This model would hold also for a pilot/aircraft system with a GPS receiver interfaced with an FMS, in which case the FMS, rather than the receiver, would be regarded as the machine part of the closed loop subsystem.

Needless to say, the uncertainty associated with any of the events mentioned above would slow down processing in the subsystem loop in Figure 2, so that the pilot is unable to access quickly the information needed for decision-making in the main loop associated with actual control of the aircraft. When frustration is added to the picture, efficiency is decreased further, and effects could then completely disrupt the complex information processing required when multitasking begins to peak, as it does during preparation for the approach phase of flight. Characteristically, the pilot engages in head-down time while struggling to gain control over the receiver, with loss of situation awareness being the risky consequent.

The effects of load on memory are very similar to those described earlier with respect to keystroke problems. When memory fails, the pilot becomes literally unable to gain efficient control with respect to the GPS receiver. With reference to Figure 2, information processing in the GPS subsystem loop is then greatly retarded, thereby preventing efficient processing in the main loop of the pilot/aircraft system. Again, head-down time, with potential for loss of situation awareness, is the undesirable result.

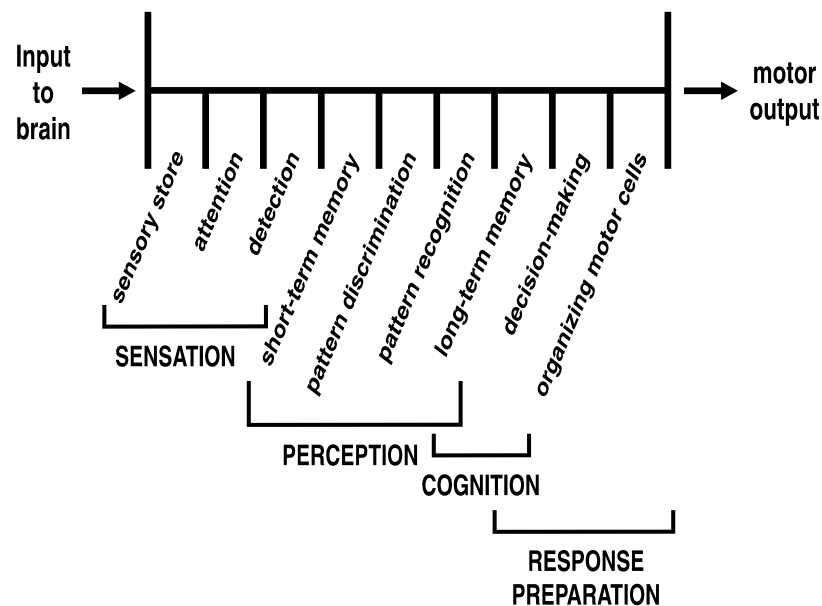
A very simplified model of how the pilot accomplishes the information-processing necessary to fly the aircraft appears in Figure 3. The process begins with input to some sensory organ,

Figure 3. The information processing time line.

say, the eye. The data are held very briefly in a sensory store for processes of attention and detection and, possibly, subsequent storage in short-term memory (STM). Pattern discrimination and recognition occur as a result of comparison of the transformed input with engrams in long-term memory (LTM), and this perceptual activity is complete when meaning has been assigned to the stimuli. Decision-making involves further interaction with LTM in order to effect an integration of the perceptual detail with other relevant information stored there. Motor cells must then be marshalled in preparation for an overt response, whereupon the response is executed. The described components of processing must be executed in the brain in an incredibly short time if the control response is to be effective.

The words "time line" in the title of Figure 3, "The information-processing time line", refer to the fact that the process as a whole can be very roughly divided into sensory, perceptual, cogni-
