RELIABILITY PERFORMANCE IN GPS RECEIVERS AND THE NATURE OF THEIR FAILURES: PLANNING TO LIVE WITH REALISTIC FAILURE RATES IN SATELLITE NAVIGATION SYSTEM RECEIVERS.

Sarah Sharkey, National Air Traffic Services Limited, London, UK
Rolf Johannessen, Lambourne Navigation Limited, Harlow, Essex, UK.

A paper given to NAV96, London, 5-6 November 1996

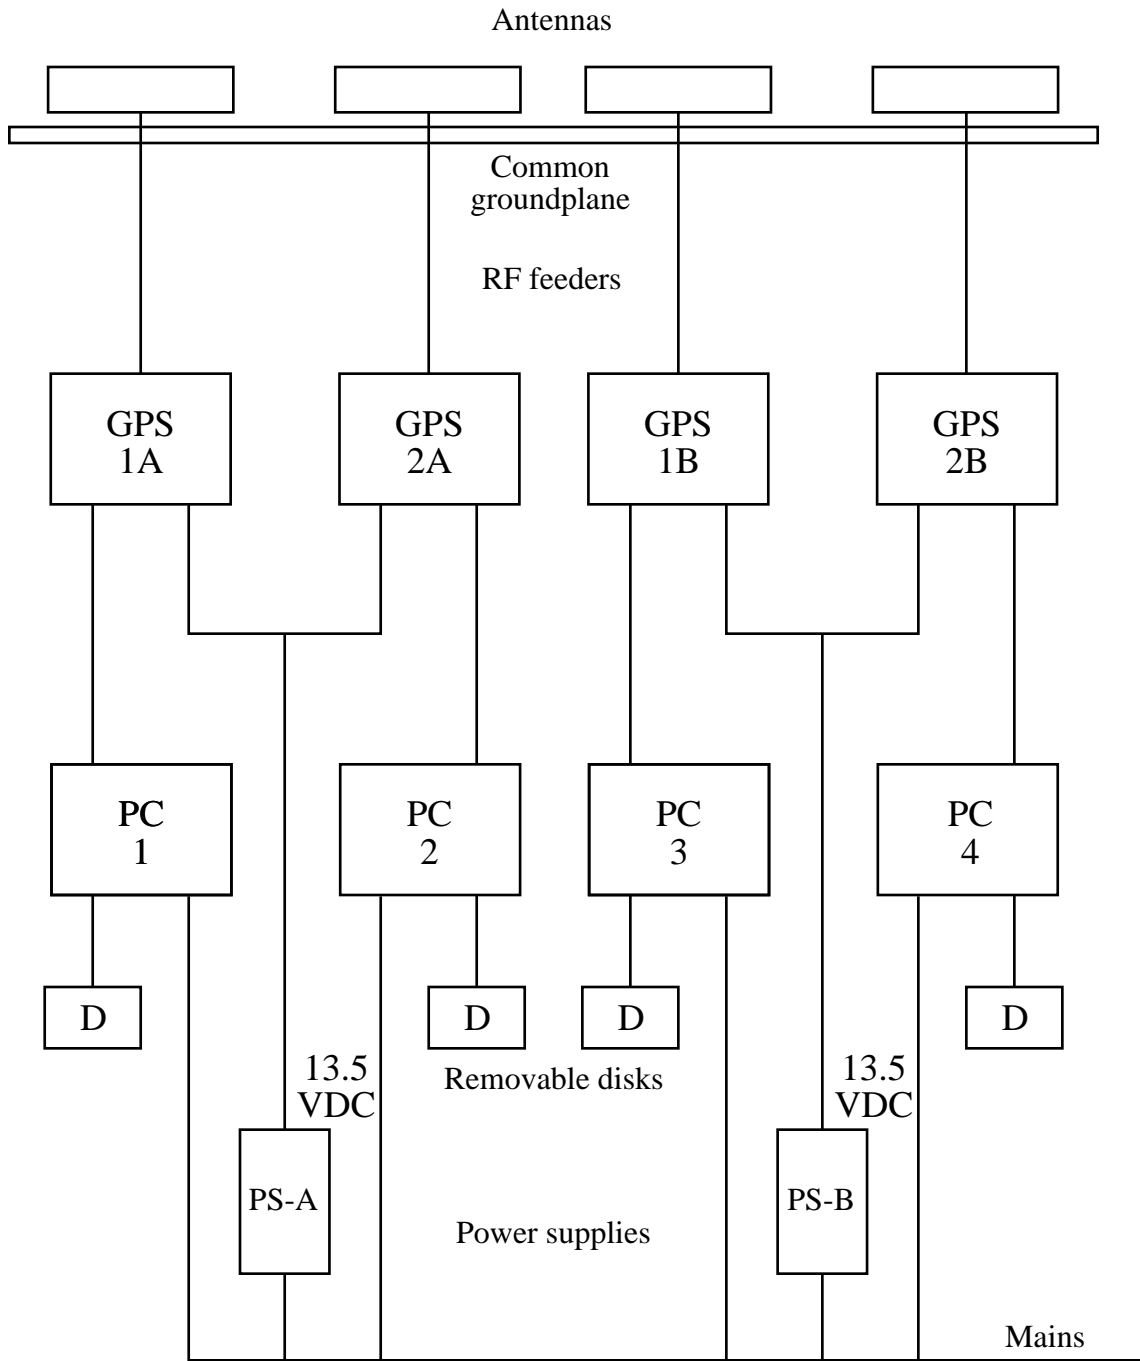
Figure 3
Equipment arrangement at Stansted

The receivers are fed from two 13.5 volt supplies and each receiver is connected to its own PC. There was no altitude input to the receivers. Figure 3 illustrates the general arrangement.
